GENERAL TOPICS VARIOUS MANUFACTURERS - VARIOUS MODELS

INTRODUCTION

This technical bulletin deals with common problems encountered on various manufacturers' vehicles by the helpline staff over the last few months. These faults have been re-occurring during this time, and the following topics detail the faults and where possible the solutions to the problems.

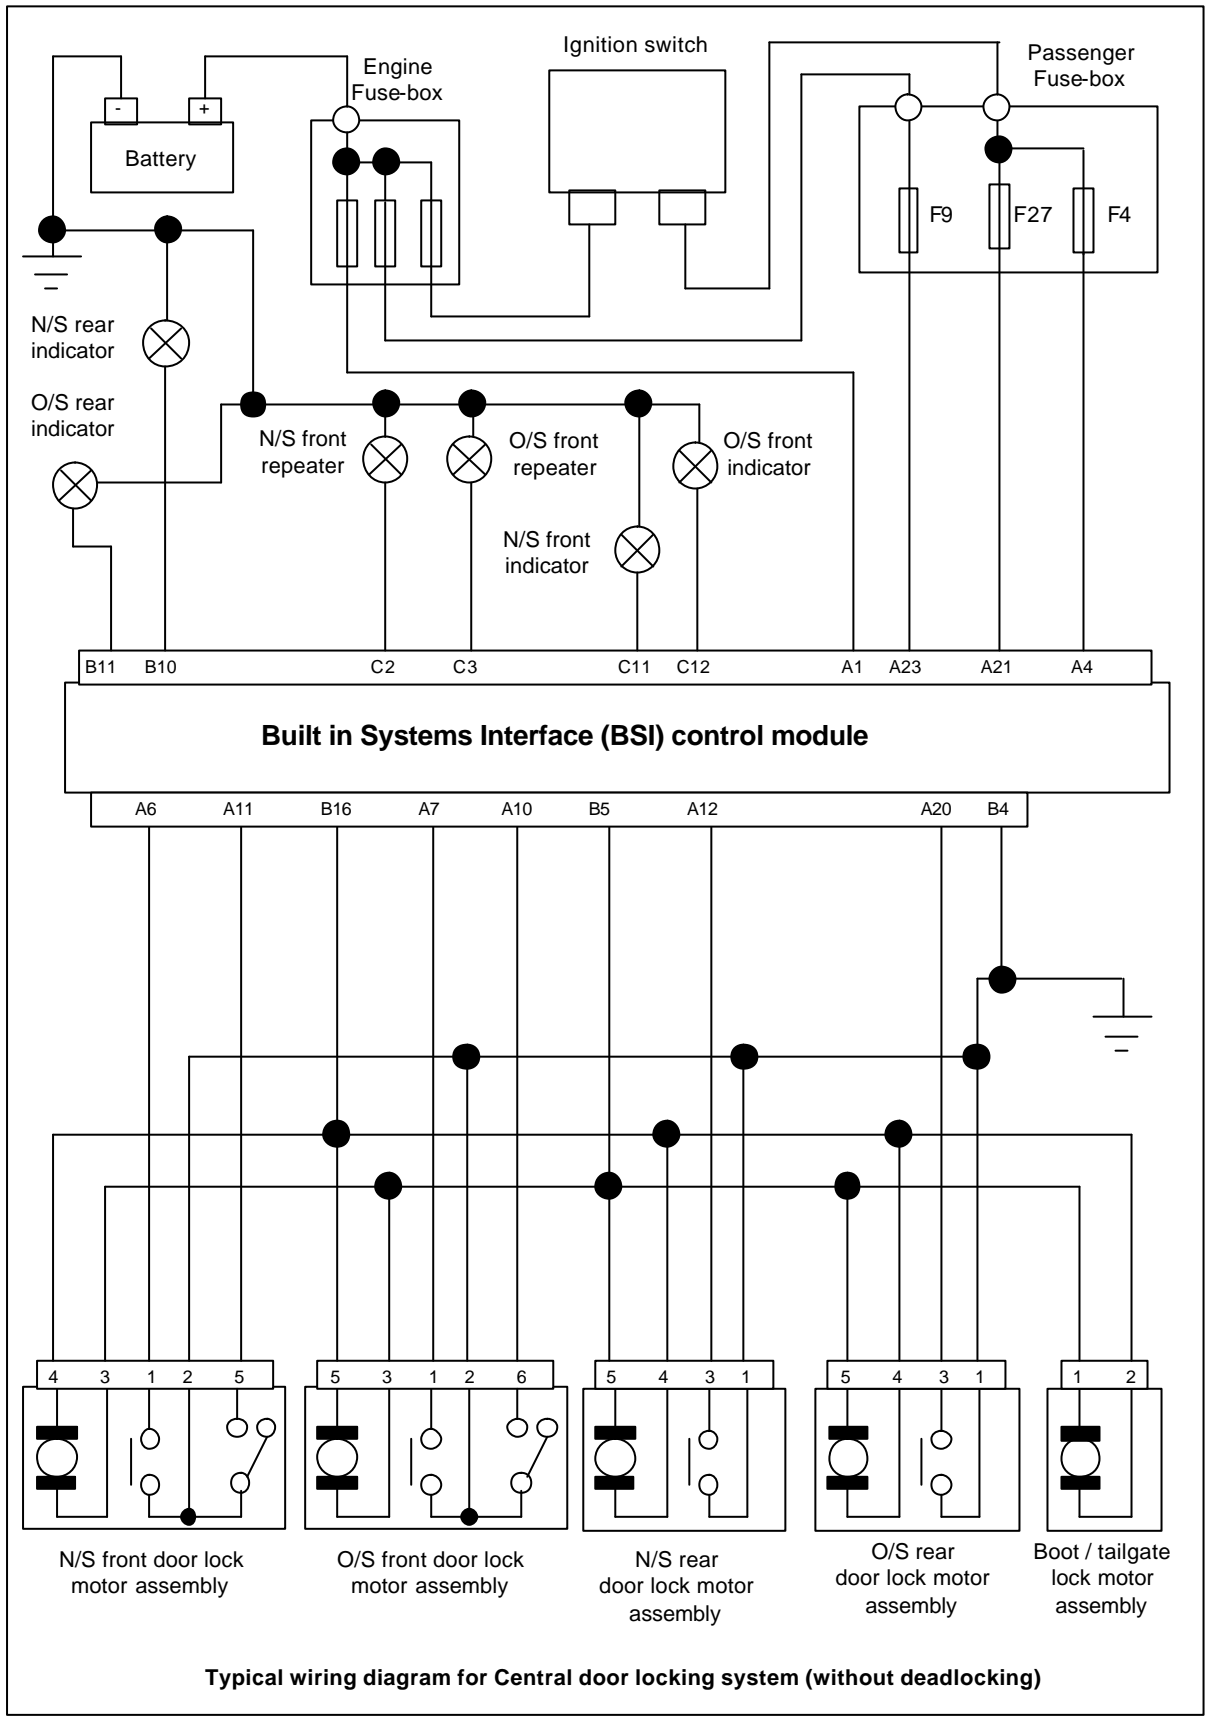
Repeated problems of Central Door Locking (CDL) failure have been traced to water ingress into the harness plug connection to the CDL unit within the door, causing bad corrosion to the terminals.

The central locking motor / switch and lock assembly are all encapsulated within one unit, and individual components cannot be renewed separately. It is not possible to diagnose CDL faults by disconnecting solenoids / switches etc because the Built in Systems Interface (BSI) control module logs a fault. Until the fault is rectified the CDL will unlock instantly.

Note. Above information in table is for Central door locking system without deadlocking. Central door locking systems with deadlocking have 8 wire latch assemblies. At present no calls have been received regarding failure or replacement of this type of Central door locking system.

Refer to the wiring diagram on the following page for details of the Central door locking system without deadlocking facilities.

Peugeot recommend replacing both the O/S and N/S CDL units together. The CDL motor / switch assemblies are wired directly to the Built In Systems Interface control module which can be found attached to the interior fuse box situated under the dash on the O/S just above the drivers right knee.

New latch assemblies (replacement of both sides is recommended by Peugeot) are supplied with different wiring / harness plug configuration i.e. new latch assemblies have different connecting plug shape / configuration. Therefore the manufacturer includes the new corresponding half of the connecting plug assembly within the replacement parts. To adapt the new latch wiring proceed as follows:

Remove existing harness plug from body wiring loom and re-connect to the new replacement harness plug in the following order.

N/S door wire unit	Original harness plug	New harness plug	Connection to CDL system
693 (orange wire)	6	1	CDL module terminal A6
M6240 (green/yellow wire)	4	2	Direct earth connection
6202 (brown wire)	2	3	CDL module terminal B5
6212 (brown wire)	7	4	CDL module terminal B16
6232 (orange wire)	3	5	CDL module A11
O/S door wire unit	Original harness plug	New harness plug	Connection to CDL system
693 (orange wire)	6	1	CDL module terminal A7
M6240 (green/yellow wire)	4	2	Direct earth connection
6202 (brown wire)	2	3	CDL module terminal B5
6212 (brown wire)	7	5	CDL module terminal B16
6232 (orange wire)	3	6	CDL module A10
